## RM of Lakeland - Lakeland Subdivisions

### FireSmart Community Assessment Report

July 20<sup>th</sup>, 2022

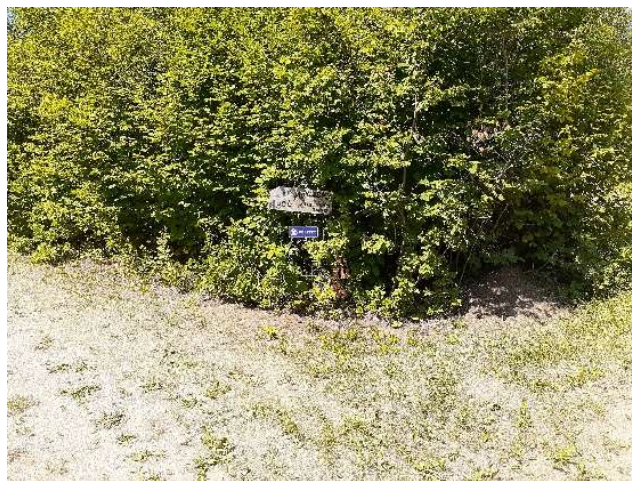
- I. Structures should be labelled with individual signs identifying the property lot and block location for emergency purposes. Signs should be clearly visible from the road and use a consistent system that provides for sequenced or patterned naming conventions. All signs should be constructed of non-combustible material such as metal posts and reflective metal placards.

Figure 1: Above picture shows wooden non-reflective partially covered by vegetation.

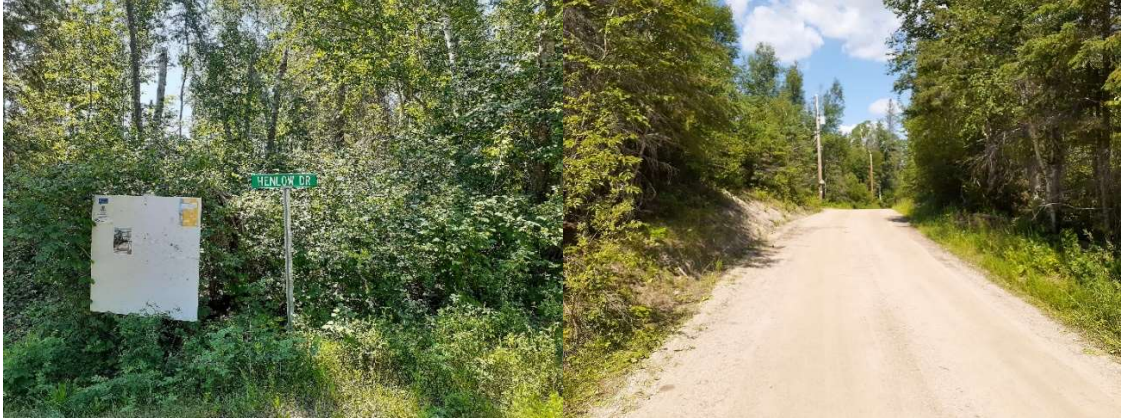
- II. There is one route of ingress and egress into the subdivision. There were reflective standard street signs throughout the subdivision. The road width in many locations is narrower than the recommend  $> 6.1$  m. Many locations had no right of way maintained with trees growing along the shoulder. Road widths should allow for simultaneous evacuation and emergency response.

Figure 2: Picture shows metal reflective street signs at subdivision entrance. Right picture showing narrow road with unmaintained shoulder.

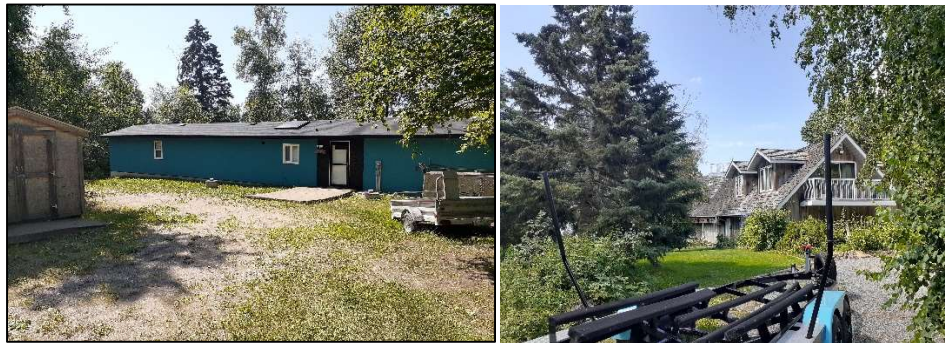
- III. Building exterior rating for the entire community is average. Most homes had vinyl or wood board siding. Vinyl or untreated shake siding provides no fire protection where stucco, metal, brick, rock or cement provide best protection for the building. Log or heavy timber provides more fire-resistant protection than normal wood board siding.
- IV. Roofing material in the subdivision was generally constructed from Type A materials like metal or asphalt. These materials are most fire resistant and remain effective under severe wildfire exposure. There were structures observed to have cedar shakes which is not recommended as cedar shake roofing provides little protection against fires. It is important that residents clean off all debris that accumulates on roof tops and within gutters.

Figure 3: Left picture showing a clean (no leaf litter) asphalt roof. Right picture showing cedar shake roof.

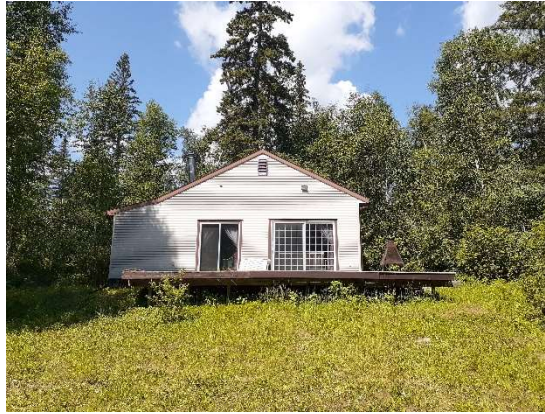
- V. Combustible wood decks attached to dwellings that are not enclosed along with buildings themselves that are not skirted or closed in were noted within the subdivisions. Decks and homes should be closed in with minimum 12mm thick sheathing. These non-protected areas

serve as ember accumulators where new spot fires can easily ignite in the tinder dry fuels that can be found in these locations.

Figure 4: Picture on left show foundation that is not skirted.

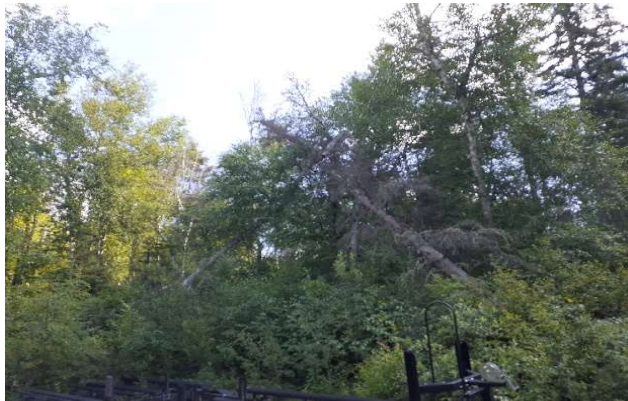
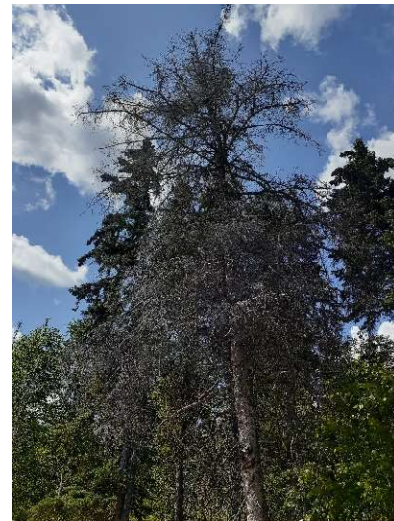
- VI. The forest stands in the area are mixed wood (aspen, poplar, birch) with pockets of conifers (mainly spruce). Seasonal risk in the surface vegetation including standing dead and down woody debris will sustain a wildland fire. Dry surface fuels are a particular concern when vegetation is cured due to drought or seasonal effects. It is recommended that residents remove all dead trees and larger shrubs within their lot to not only to reduce their fire risk but the potential damage to structures and infrastructure if they were to break off or blow down.

Figure 5: Figures above – Mixed wood stand with dead conifers

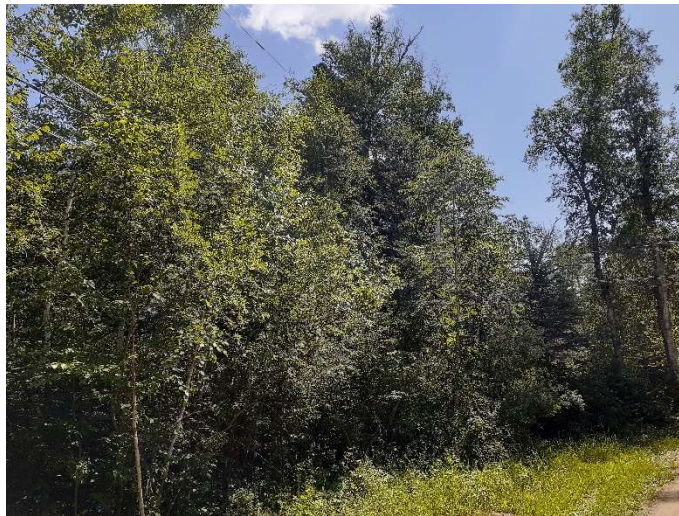
Figure 6: Pruning and maintaining trees close to utility lines and power lines should be completed in areas.

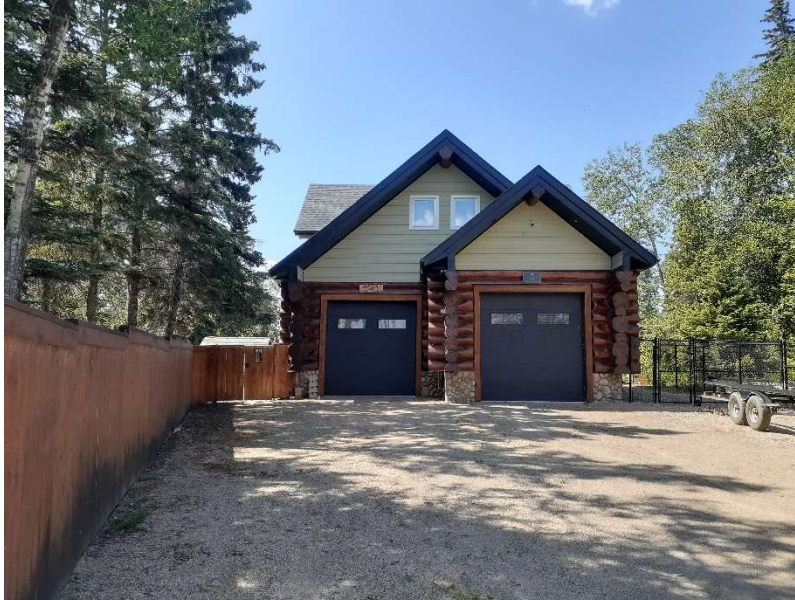
Figure 7: Houses on left shown with clean asphalt, log construction, minimal vegetation against structure and gravel right up to the home.

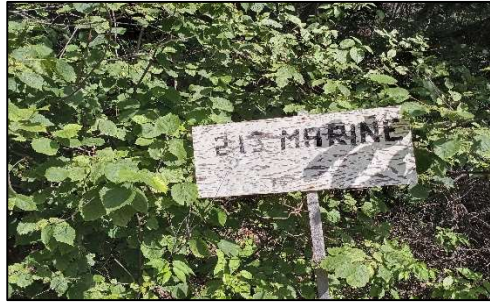
- I. Structures should be labelled with individual signs identifying the property lot and block location for emergency purposes. Signs should be clearly visible from the road and use a consistent system that provides for sequenced or patterned naming conventions. All signs

should be constructed of non-combustible material such as metal posts and reflective metal placards.

Figure 1: Above picture shows wooden non-reflective partially covered by vegetation.

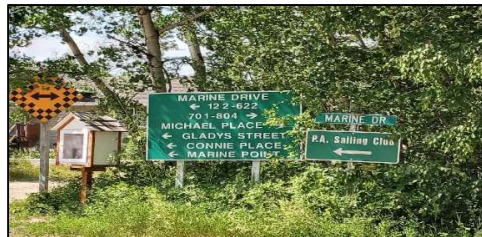
Figure 2: Picture shows metal reflective street signs at subdivision entrance.

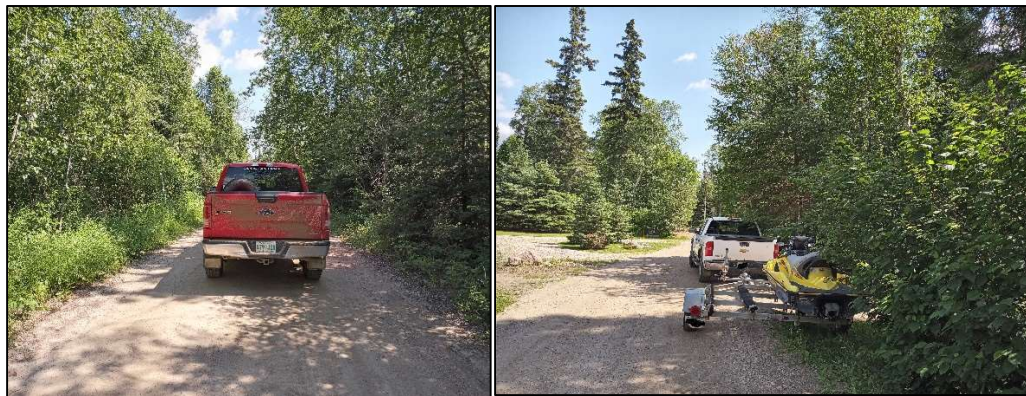
- II. There is one route of ingress and egress into the subdivision. There were reflective standard street signs throughout the subdivision. The road width in many locations is narrower than the recommend  $> 6.1$  m. Many locations had no right of way maintained with trees growing along the shoulder. Road widths should allow for simultaneous evacuation and emergency response.

Figure 3: Left picture showing narrow road driving surface and unmaintained shoulder. Right picture showing minimal available driving surface when vehicles parked on edge of road.

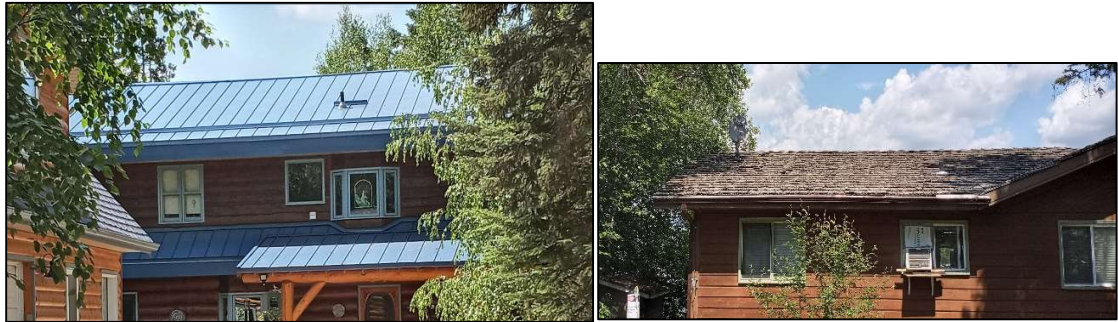
- III. Building exterior rating for the entire community average. Most homes had vinyl or wood board siding. Vinyl or untreated shake siding provides no fire protection where stucco, metal, brick, rock or cement provide best protection for the building. Log or heavy timber provides more fire-resistant protection than normal wood board siding.
- IV. Roofing material in the subdivision was generally constructed from Type A materials like metal or asphalt. These materials are most fire resistant and remain effective under severe wildfire exposure. There were structures observed to have cedar shakes which is not

recommended as cedar shake roofing provides little protection against fires. It is important that residents clean off all debris that accumulates on roof tops and within gutters.

Figure 4: Left picture showing a clean (no leaf litter) metal roof. Right picture showing cedar shake roof.

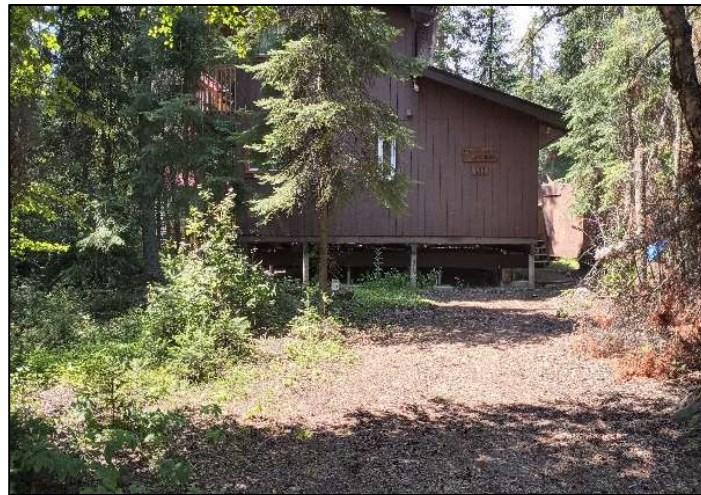
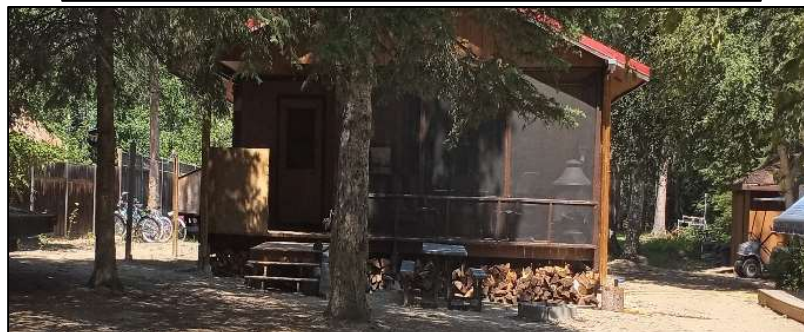
- V. Combustible wood decks attached to dwellings that are not enclosed along with buildings themselves that are not skirted or closed in were noted within the subdivisions. Decks and homes should be closed in with minimum 12mm thick sheathing. These non-protected areas serve as ember accumulators where new spot fires can easily ignite in the tinder dry fuels that can be found in these locations.

Figure 5: Picture above show foundation that is not skirted. Picture below showing firewood stored underneath deck. Embers could enter and ignite dry leaf litter and firewood in these areas.

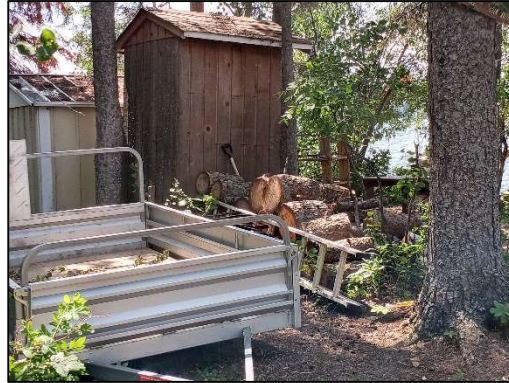
- VI. Another area of concern was seasoned firewood or other wood combustibles piled directly against the home or other structures. These areas serve as locations where ignition can occur

from flying embers, even from a simple unattended nearby campfire. It is recommended that firewood be stored away from structures and the amount is limited to one years use. Fire wood that is stacked against live standing trees can act as ladder fuels for fire to reach the canopy and increase fire intensity.

**Figure 6: Firewood and other combustibles stored between trees (ladder fuel) and too close to structures provide ignition points and fuel for wildfires.**

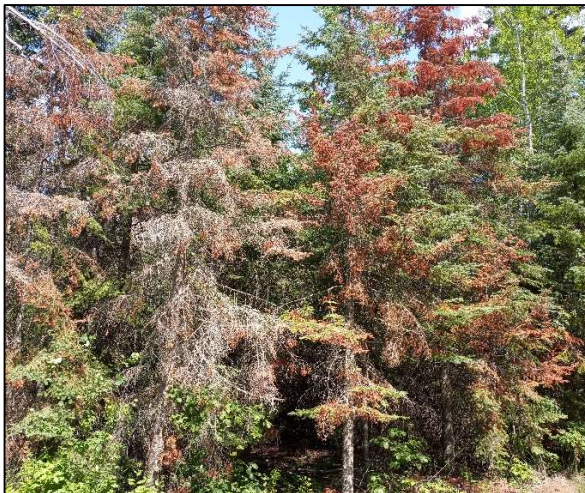
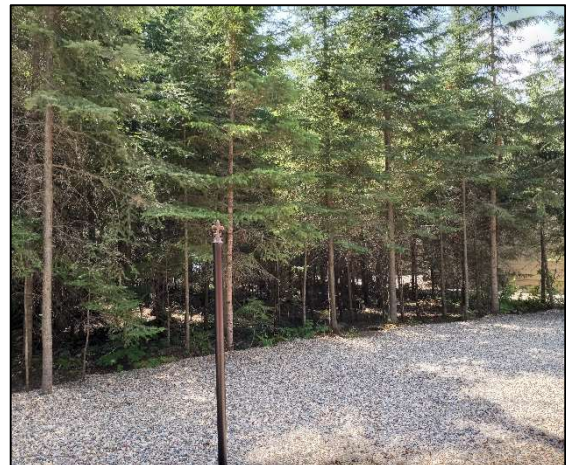
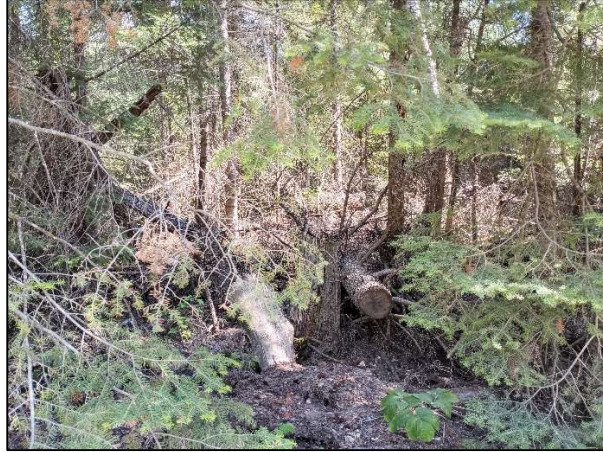
- VII. The forest stands in the area are mixed wood (aspen, poplar, birch) with pockets of dense conifers (balsam fir and spruce). Seasonal risk in the surface vegetation including standing dead and down woody debris will sustain a wildland fire. Dry surface fuels are a particular concern when vegetation is cured due to drought or seasonal effects. It is recommended that residents remove all dead trees and larger shrubs within their lot to not only to reduce their fire risk but the potential damage to structures and infrastructure if they were to break off or blow down.

Figure 7: Figures above – thick conifer understory with dead standing and downed trees.

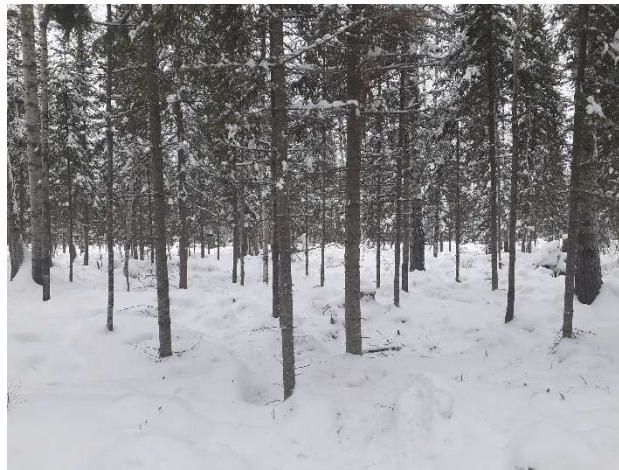
Figure 8: Example of a thinned & pruned conifer stand (Sled Lake – Winter 2022).

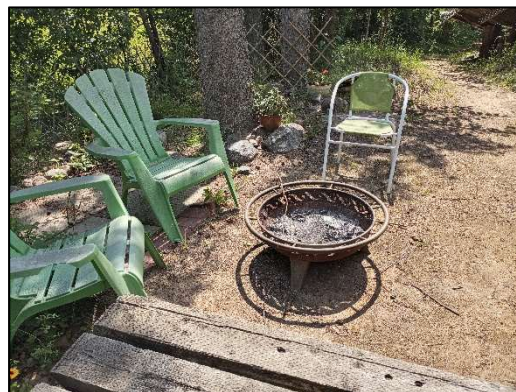
- VIII. Being in a lake community, many people have and enjoy the use of a fire pit. All fire pits should be screened with mesh not exceeding 12mm, located on clean rock, concrete, sand or mineral soil, and should have a minimum of 1 m non combustible area surrounding the fire pit. The pit is to be constructed of metal or concrete and in good condition with no rusting or breaks.

Figure 9: Firepit surrounded by noncombustible material, however, recommend the use of mesh to control sparks.

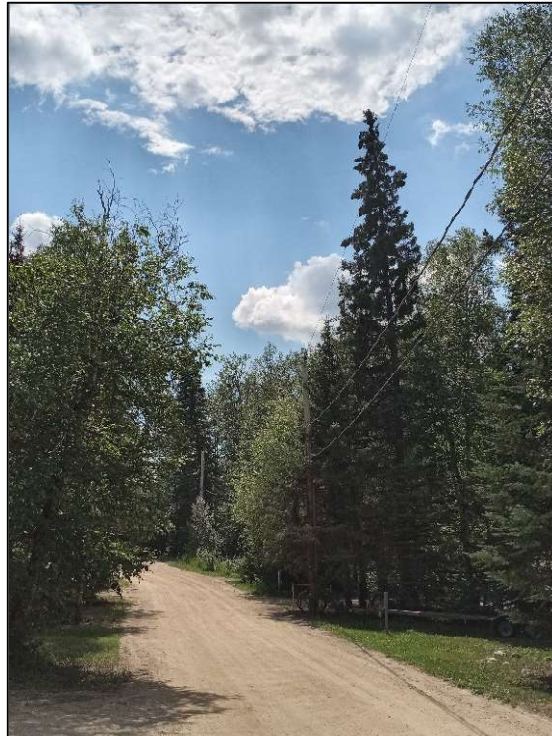
Figure 10: Pruning and maintaining trees close to utility lines and power lines should be completed in areas.

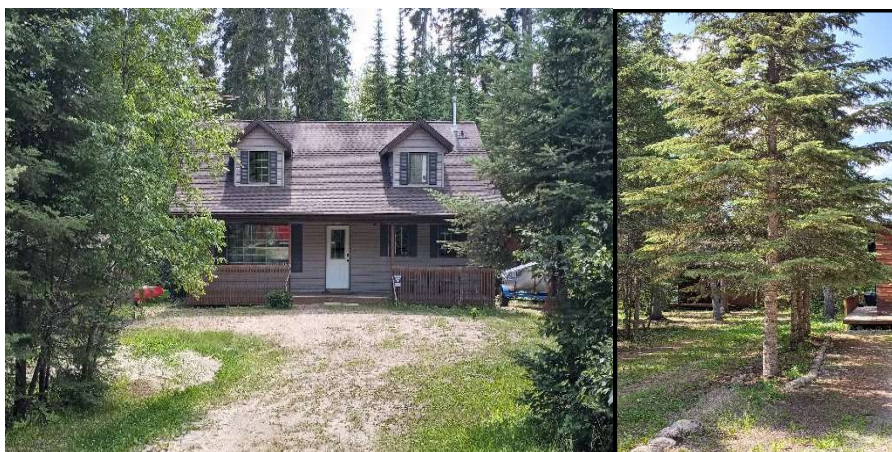
Figure 11: Houses on left shown with clean asphalt, minimal vegetation against structure. Right picturing showing pruned conifers.

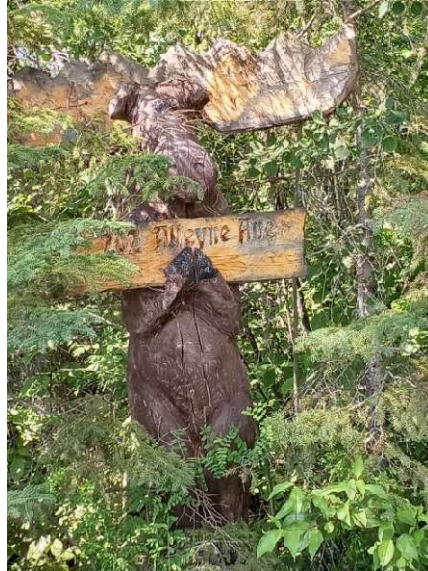
- I. Structures should be labelled with individual signs identifying the property lot and block location for emergency purposes. Signs should be clearly visible from the road and use a consistent system that provides for sequenced or patterned naming conventions. All signs should be constructed of non-combustible material such as metal posts and reflective metal placards.

Figure 1: Above picture shows wooden non-reflective partially covered by vegetation.

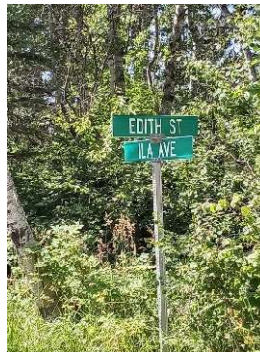
Figure 2: Picture shows metal reflective street signs in subdivision.

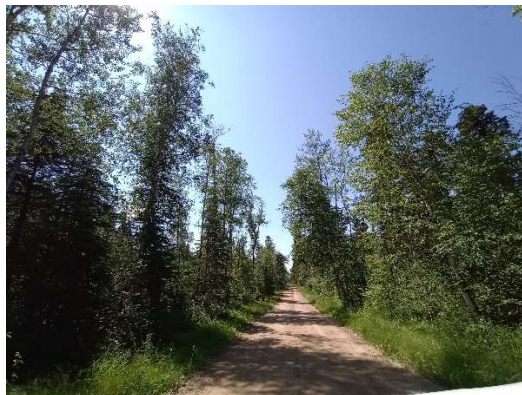
- II. There is one route of ingress and egress into the subdivision. There were reflective standard street signs throughout the subdivision. The road width in many locations is narrower than the recommend > 6.1 m. Many locations had no right of way maintained with trees growing along the shoulder. Road widths should allow for simultaneous evacuation and emergency response.

Figure 3: Left picture showing narrow road driving surface and unmaintained shoulder.

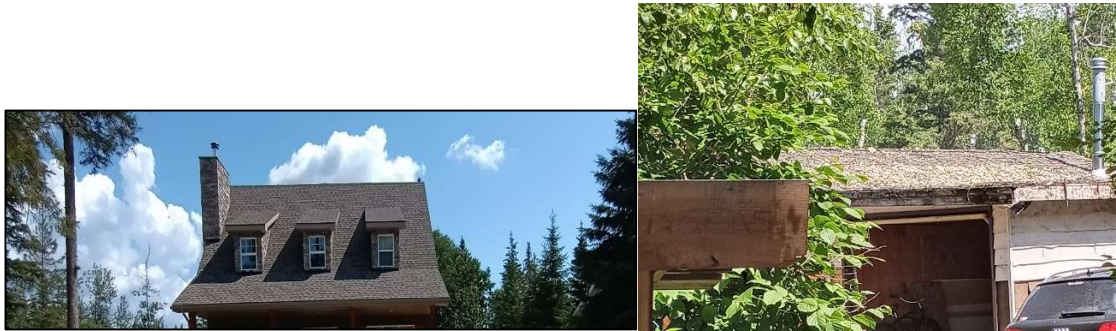
- III. Building exterior rating for the entire community average. Most homes had vinyl or wood board siding. Vinyl or untreated shake siding provides no fire protection where stucco, metal, brick, rock or cement provide best protection for the building. Log or heavy timber provides more fire-resistant protection than normal wood board siding.
- IV. Roofing material in the subdivision was generally constructed from Type A materials like metal or asphalt. These materials are most fire resistant and remain effective under severe wildfire exposure. There were structures observed to have cedar shakes which is not recommended as cedar shake roofing provides little protection against fires. It is important that residents clean off all debris that accumulates on roof tops and within gutters.

Figure 4: Left picture showing a clean (no leaf litter) asphalt roof. Right picture showing cedar shake roof covered in debris.

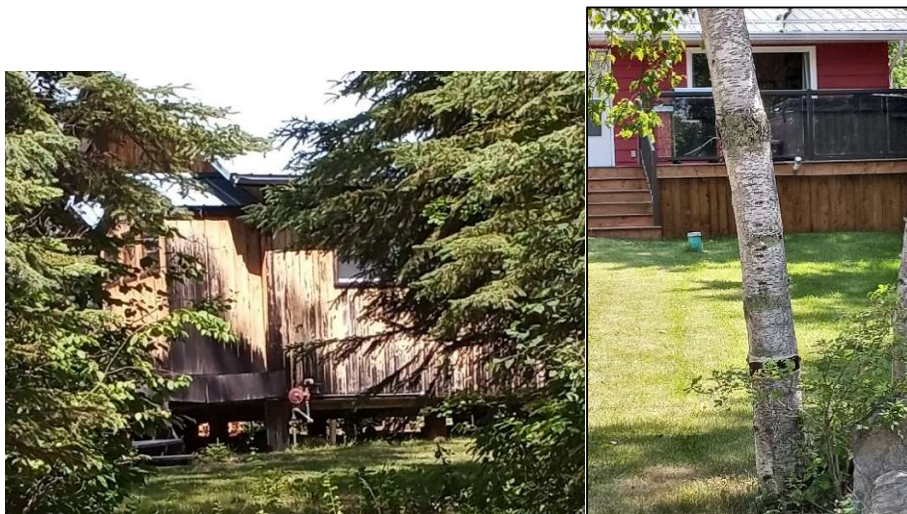
- V. Combustible wood decks attached to dwellings that are not enclosed along with buildings themselves that are not skirted or closed in were noted within the subdivisions. Decks and homes should be closed in with minimum 12mm thick sheathing. These non-protected areas serve as ember accumulators where new spot fires can easily ignite in the tinder dry fuels that can be found in these locations.

Figure 5: Picture on left show foundation that is not skirted. Picture on right showing skirted in deck area.

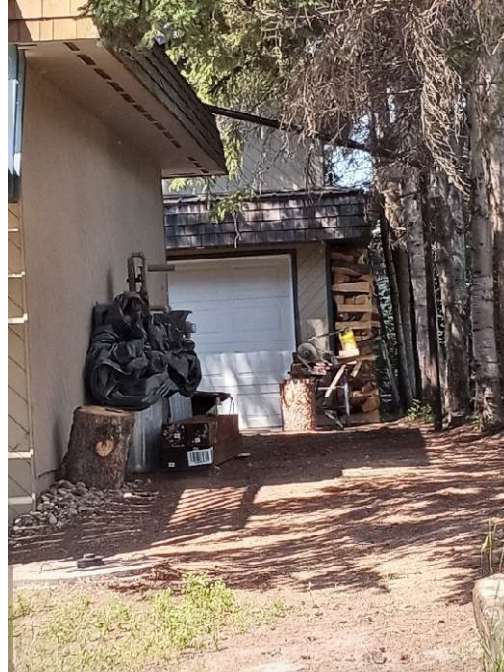
- VI. Another area of concern was seasoned firewood or other wood combustibles piled directly against the home or other structures. These areas serve as locations where ignition can occur

from flying embers, even from a simple unattended nearby campfire. It is recommended that firewood be stored away from structures and the amount is limited to one years use. Fire wood that is stacked against live standing trees can act as ladder fuels for fire to reach the canopy and increase fire intensity.

**Figure 6: Firewood and other combustibles stored next to structures provide ignition points and fuel for wildfires.**

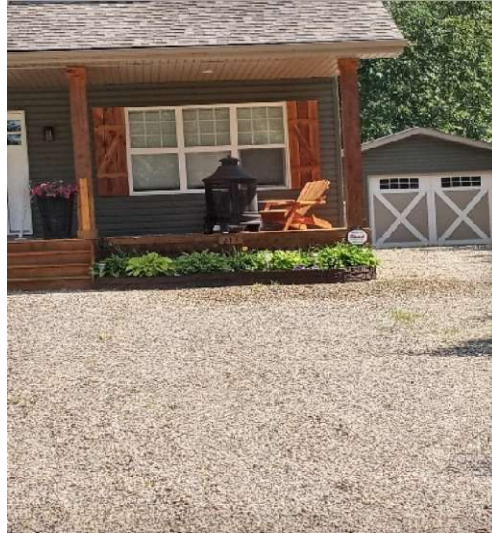
- VIII. Being in a lake community, many people have and enjoy the use of a fire pit. All fire pits should be screened with mesh not exceeding 12mm, located on clean rock, concrete, sand or mineral soil, and should have a minimum of 1 m non combustible area surrounding the fire pit. The pit is to be constructed of metal or concrete and in good condition with no rusting or breaks.

**Figure 7: Firepit made of steel mesh that should be moved off of deck to the gravel area before use and away from the structure.**

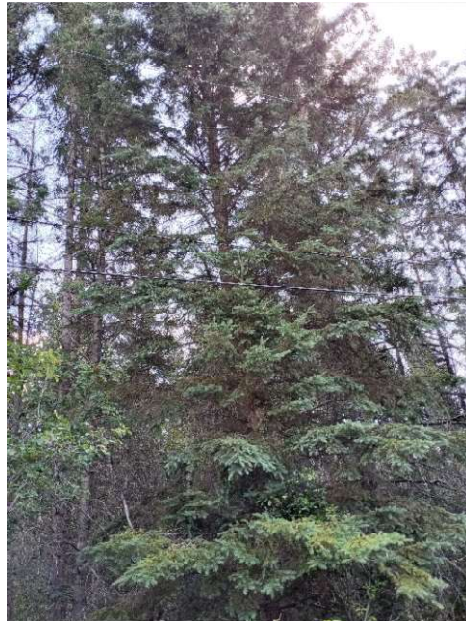
**Figure 8: Pruning and maintaining tress close to utility lines and power lines should be completed in areas.**

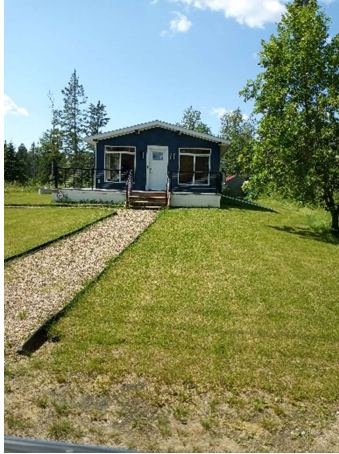
Figure 9: Houses on left shown with clean gravel walkway, minimal vegetation against structure and skirted deck area.

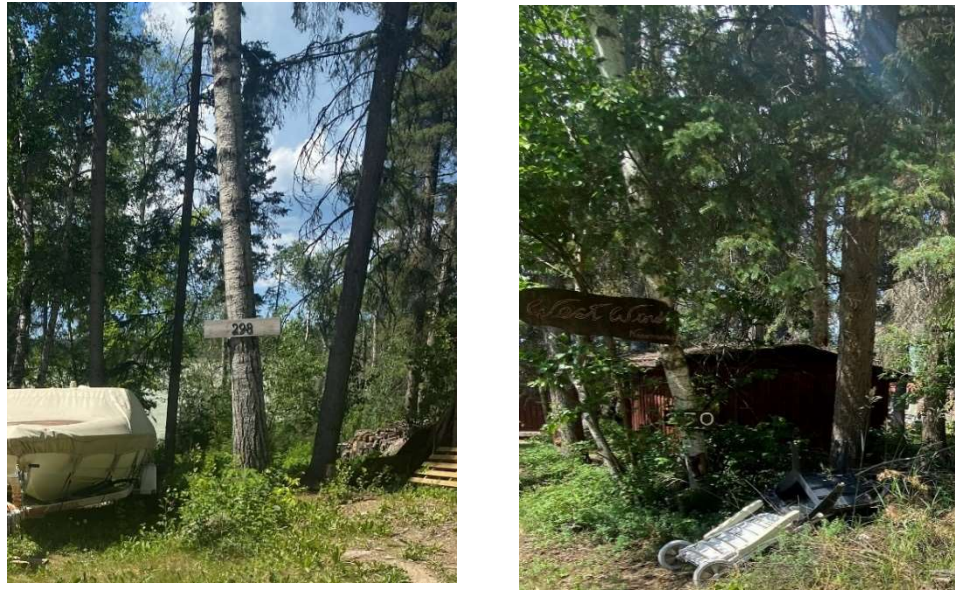
- I. Structures should be labelled with individual signs identifying the property lot and block location for emergency purposes. Signs should be clearly visible from the road and use a consistent system that provides for sequenced or patterned naming conventions. All signs should be constructed of non-combustible material such as metal posts and reflective metal placards.

Figure 1: Wooden signs nailed to trees, foliage blocking signs

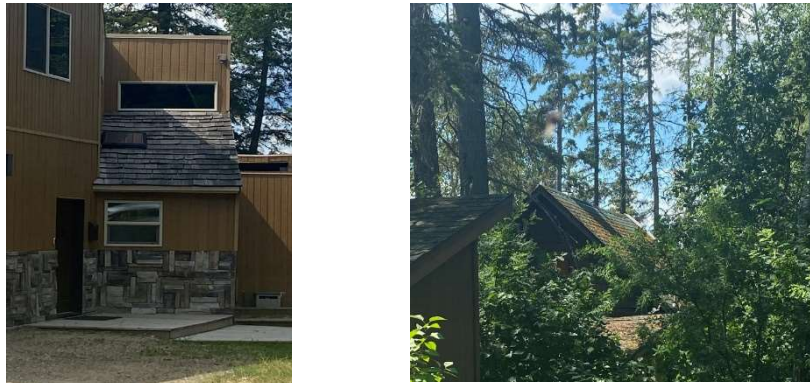
- II. Building exterior rating for the entire subdivision was average. Most homes had vinyl or wood board siding. Vinyl or untreated shake siding provides no fire protection where stucco, metal, brick, rock or cement provide best protection for the building. Log or heavy timber provides more fire-resistant protection than normal wood board siding
- III. Roofing material in the subdivision was generally constructed from Type A materials like metal or asphalt. These materials are most fire resistant and remain effective under severe wildfire exposure. There were structures observed to have cedar shakes which is not recommended as cedar shake roofing provides little protection against fires. It is important that residents clean off all debris that accumulates on roof tops and within gutters.

Figure 2: Cedar shakes and accumulated debris on roof.

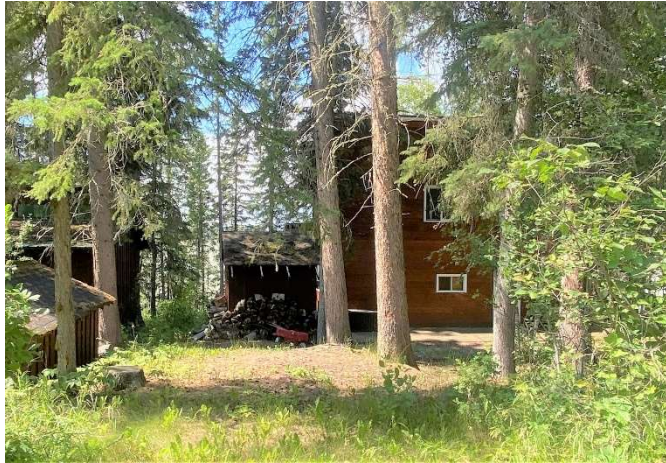
- IV. Another area of concern was seasoned firewood or other wood combustibles piled directly against the home or other structures. These areas serve as locations where ignition can occur from flying embers, even from a simple unattended nearby campfire. It is recommended that firewood be stored away from structures and the amount is limited to one year's use. Firewood that is stacked against live standing trees can act as ladder fuels for fire to reach the canopy and increase fire intensity.

Figure 3: Firewood stored too close to structures provide ignition points and fuel for wildfires.

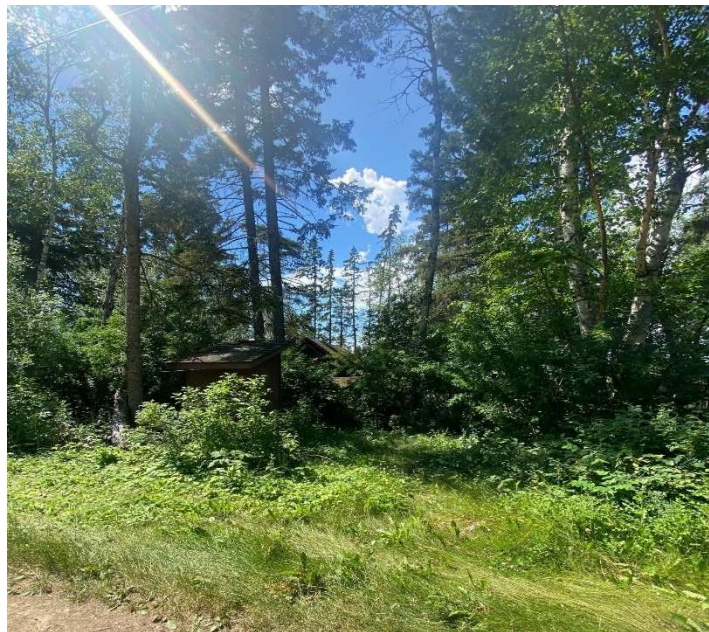
- V. The forest stand in the area are primarily composed of white spruce, aspen, poplar, and shrubs. It's recommended keeping the first one to three meters around the base of your cabin and any outbuildings completely free of fuel for a fire.

Figure 4: Overgrown vegetation too close to structures.

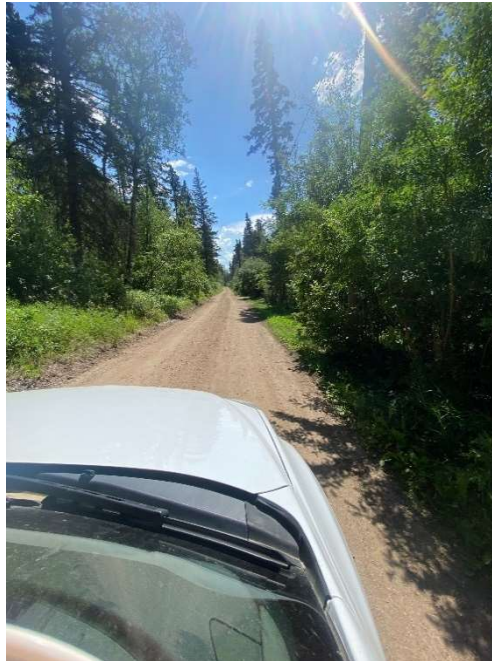
- VI. Width of road should allow for simultaneous and emergency response. Therefore, should be able to handle load of largest emergency fire apparatus typically used.

Figure 5: Road not wide enough for parking along roadway.
