Anglin Lake Subdivision – RM of Lakeland

FireSmart Community Assessment Report

July 19, 2022

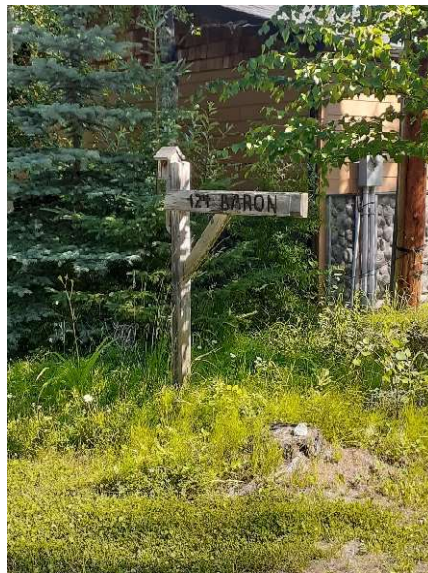
- I. Structures should be labelled with individual signs identifying the property lot and block location for emergency purposes. Signs should be clearly visible from the road and use a consistent system that provides for sequenced or patterned naming conventions. All signs should be constructed of non-combustible material such as metal posts and reflective metal placards.

Figure 1: Above picture shows wooden non-reflective sign.

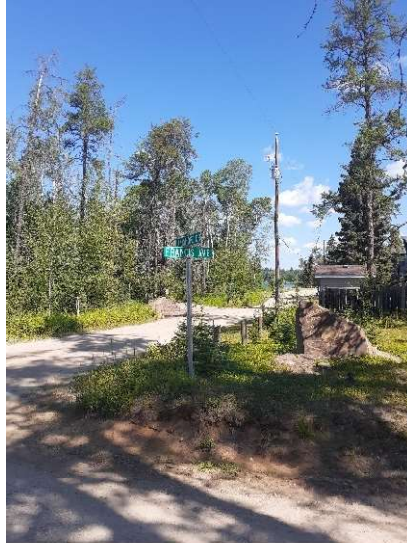
- II. There are two routes of ingress and egress in the subdivision. There were few reflective standard street signs throughout the subdivision. The road width in many locations is narrower than the recommend > 6.1 m. However, there was a turnaround large enough to accommodate emergency vehicles. Many locations had no right of way maintained with trees growing along the shoulder. Road widths should allow for simultaneous evacuation and emergency response.

Figure 2: Picture shows metal reflective street signs at subdivision entrance.

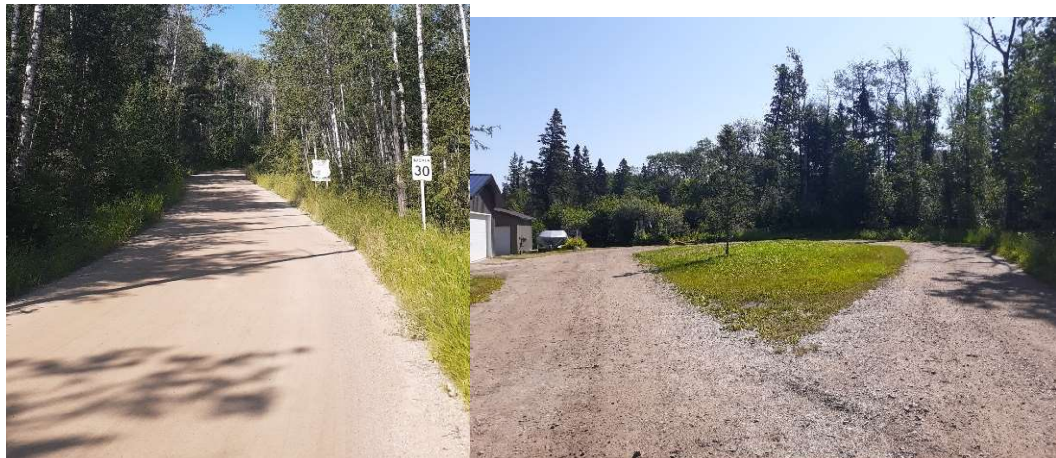
Figure 3: Left picture showing narrow road driving surface and unmaintained shoulder. Right picture showing large turnaround .

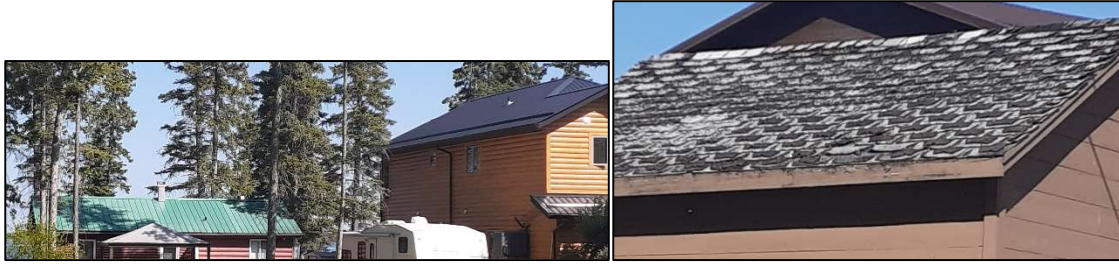
- III. Building exterior rating for the entire community average. Most homes had vinyl or wood board siding. Vinyl or untreated shake siding provides no fire protection where stucco, metal, brick, rock or cement provide best protection for the building. Log or heavy timber provides more fire-resistant protection than normal wood board siding.
- IV. Roofing material in the subdivision was generally constructed from Type A materials like metal or asphalt. These materials are most fire resistant and remain effective under severe wildfire exposure. There were structures observed to have cedar shakes which is not recommended as cedar shake roofing provides little protection against fires. It is important that residents clean off all debris that accumulates on roof tops and within gutters.

Figure 4: Left picture showing a clean (no leaf litter) metal roofs. Right picture showing asphalt shingles needing replacement.

- Establishment of a “fire free zone”, allowing no fire to ignite or burn on or within 1.5 metres of a structure by removing easily ignited fuels located within this zone.
 - Keep roofs and rain gutters/eaves trough free from leaves, dried needles, and twigs. Incorporate yearly cleaning of gutters when performing spring yard cleaning.

- If your cottage/home has non-treated cedar shakes, consider replacing with less flammable class A asphalt or metal roofing or setting up sprinkler heads on the roof that could be activated if a wildfire did occur.

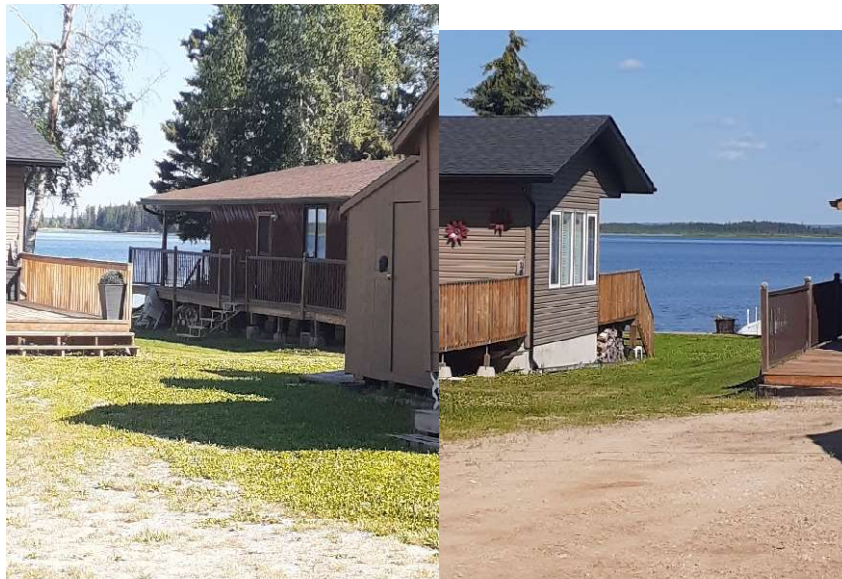
- V. Combustible wood decks attached to dwellings that are not enclosed along with buildings themselves that are not skirted or closed in were noted within the subdivisions. Decks and homes should be closed in with minimum 12mm thick sheathing. These non-protected areas serve as ember accumulators where new spot fires can easily ignite in the tinder dry fuels that can be found in these locations.

Figure 5: Both pictures showing unskirted decks with dry firewood underneath. Embers could enter and ignite dry leaf litter and firewood in these areas.

- Stacked firewood, bark mulch or wooden building material piled directly against home or under structures should be moved a minimum of 10 metres away or screened in to prevent ignitions.

- Homes, decks, and other structures should be skirted in to prevent accumulations of dried fuels. These open areas allow embers to blow in and start spot fires under the structures. Make a point during spring yard cleaning to rake and remove any accumulations of fuels such as dried leaves, needles, and twigs from under wooden decks and structures. Best protection would be to screen decks and skirt all buildings with 3 mm wire mesh or minimum 12mm thick wood sheathing.

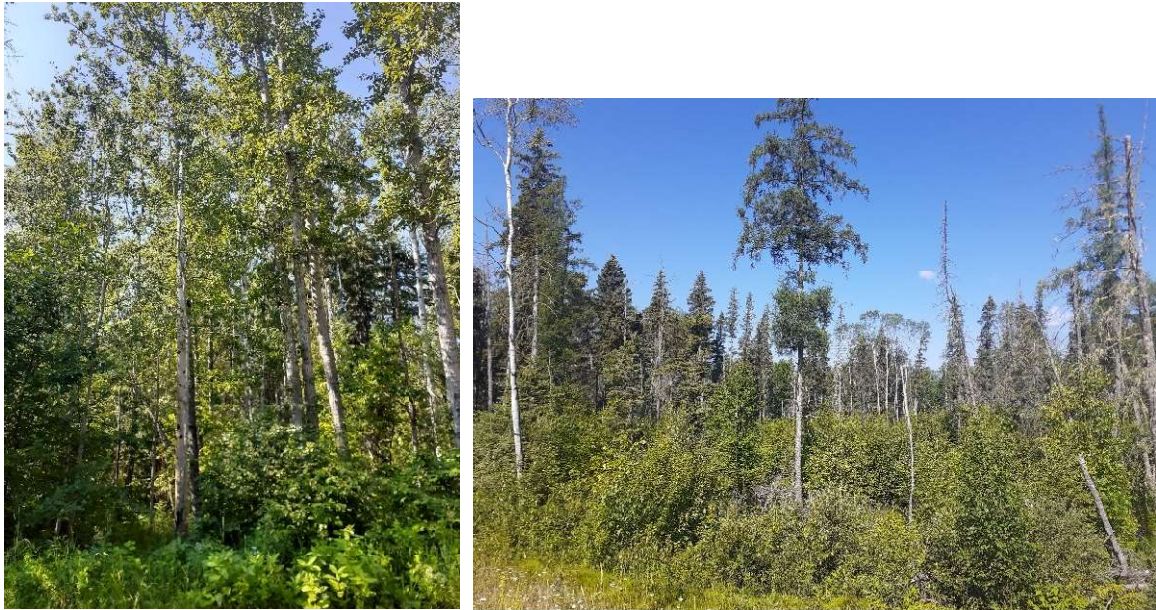
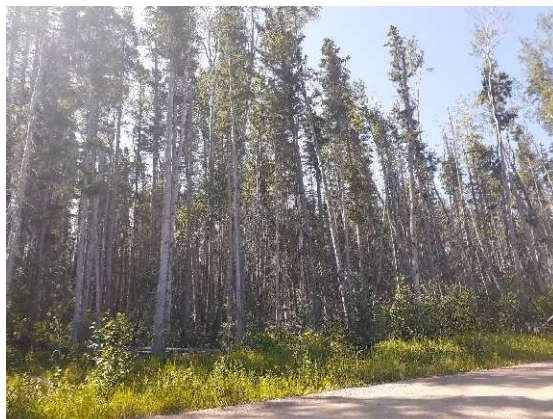
- VI. Another area of concern was seasoned firewood or other wood combustibles piled directly against the home or other structures. These areas serve as locations where ignition can occur from flying embers, even from a simple unattended nearby campfire. It is recommended that firewood be stored away from structures and the amount is limited to one years use. Fire wood that is stacked against live standing trees can act as ladder fuels for fire to reach the canopy and increase fire intensity.
- VII. The forest stands in the area are mixed wood (aspen, popular, birch) with pockets of dense conifers (balsam fir and spruce). Seasonal risk in the surface vegetation including standing dead and down woody debris will sustain a wildland fire. Dry surface fuels are a particular concern when vegetation is cured due to drought or seasonal effects. It is recommended that residents

remove all dead trees and larger shrubs within their lot to not only to reduce their fire risk but the potential damage to structures and infrastructure if they were to break off or blow down.

Figure 6: Figures above – mixed wood stands with areas of pure conifers along with dead standing and downed trees.

- Remove hazardous fuels within the “home ignition zone”. The home ignition zone includes the fire free zone and encompasses the area within 10 metres from the home or building structure. This includes 10 m from any flammable attached wooden decks. This would include the removal, thinning and pruning of spruce, pine and cedar trees and the removal of any brush, leaves and other debris within this area. Any remaining spruce and pine trees should be pruned to a height of 2 m if there is any flammable vegetation under them.

- Add 8 – 12 mm wire mesh screens for over fire pits and create a 1 m wide fire resistant strip around the fire pits.
- Fuel management options within the community could include the thinning and removal of any dead and down trees within the deciduous stands to further reduce the risk of fire. Also mowing and maintaining annual grasses to 10 cm or less would reduce the fine fuel build up.

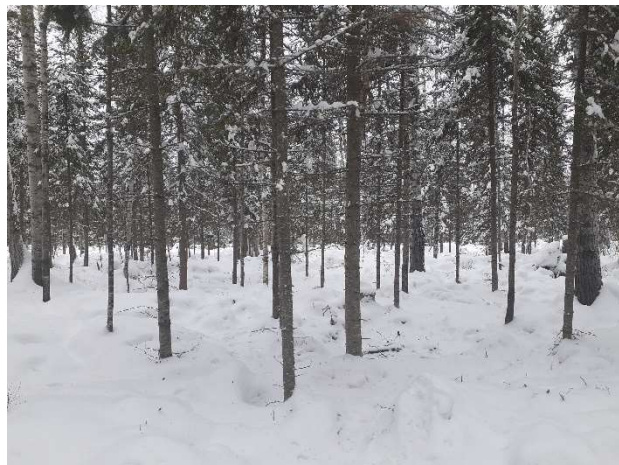
Figure 7: Example of a thinned & pruned conifer stand (Sled Lake – Winter 2022).

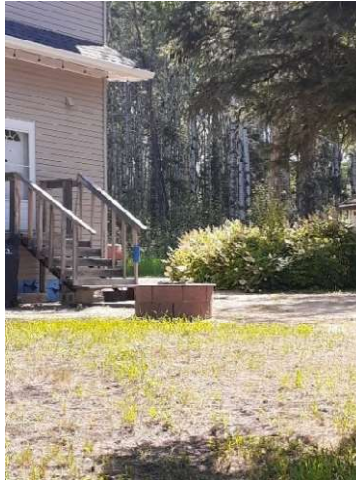
- VIII. Being in a lake community, many people have and enjoy the use of a fire pit. All fire pits should be screened with mesh not exceeding 12mm, located on clean rock, concrete, sand or mineral soil, and should have a minimum of 1 m non combustible area surrounding the fire pit. The pit is to be constructed of metal or concrete and in good condition with no rusting or breaks.

Figure 8: Firepit surrounded by noncombustible material, however, recommend the use of mesh to control sparks.

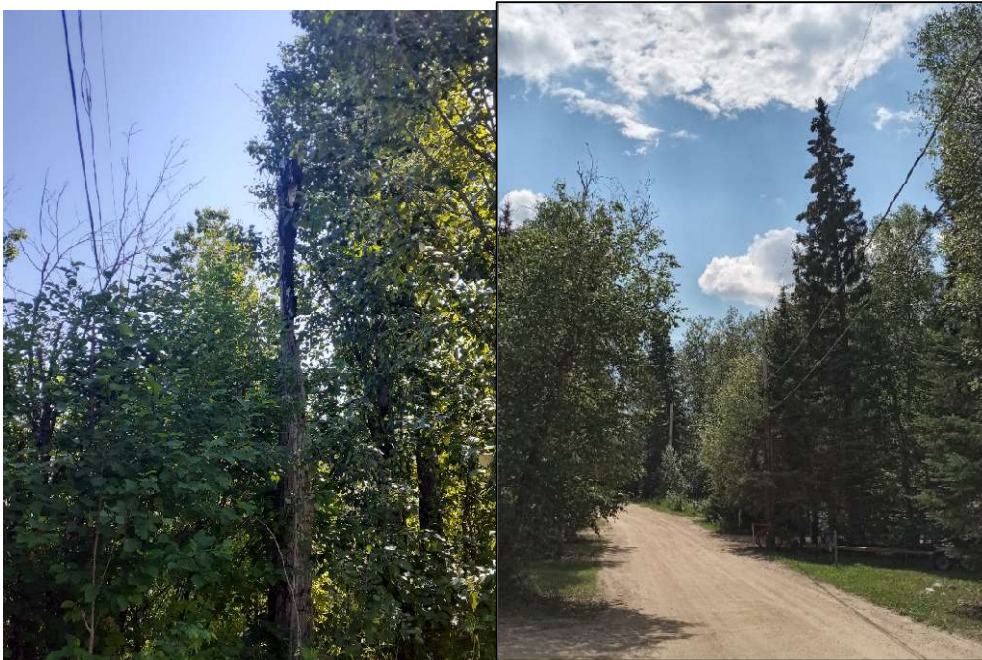
- IX. The risk for accidental human caused fires is generally higher in populated areas. Accidental ignition includes fire pits, fireworks and improper disposal of smoking material. Overhead powerlines near vegetation and propane tanks amidst vegetation or adjacent to buildings are also ignition sources that are highly apparent.

Figure 9: Pruning and maintaining trees close to utility lines and power lines should be completed in areas.

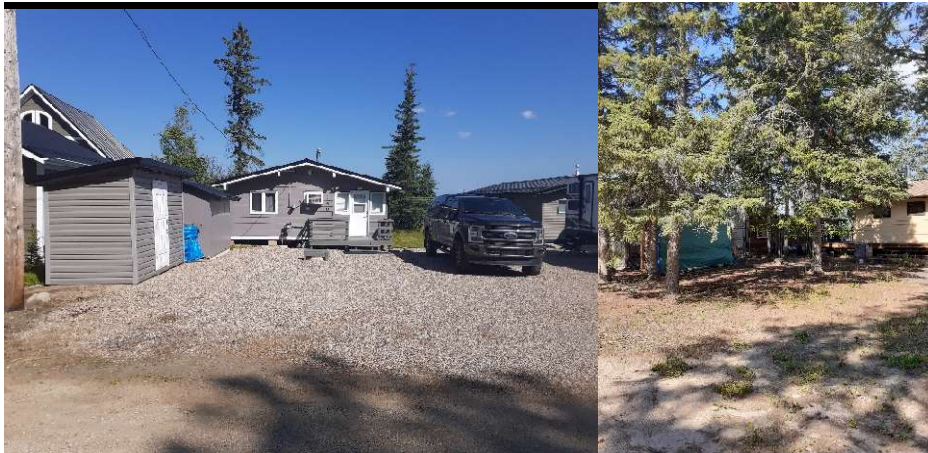
XI. The pictures below show some examples of good FireSmart practices within the community.

Figure 10: Houses on left shown with clean asphalt, minimal vegetation against structure. Right picturing showing pruned conifers.
